## Catholic Church of St Francis of Assisi

Coronation Road, Ascot, SL5 9HG

**Quinquennial Inspection Report** July 2017 Issue 1

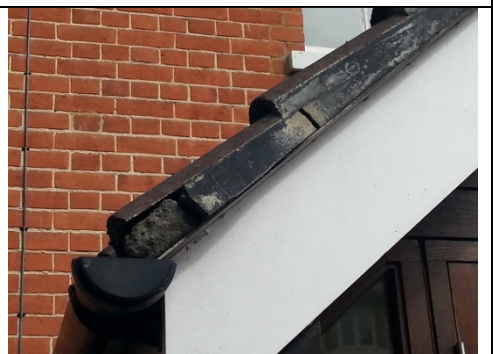
No.	Condition	Repair Need	Repair Type	Photograph
4.1.1	Front verge of the entrance porch roof. The mortar pointing has been displaced.	Cut out loose verge pointing and replace.	C

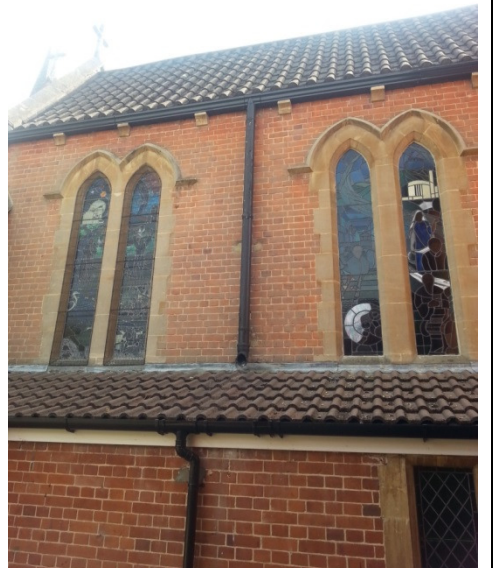
No.	Condition	Repair Need	Repair Type	Photograph
4.4.1	None at present. The main roof discharges via downpipes onto the tiled roofs below. Over time this may lead to early deterioration of the tiles on the lower roof.	None	-

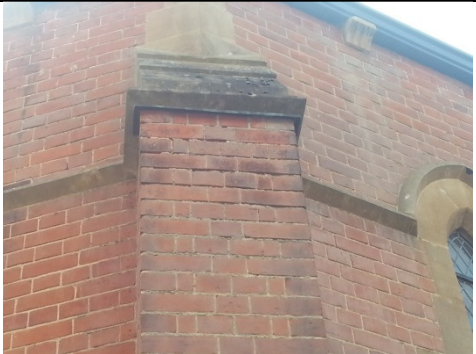
No.	Condition	Repair Need	Repair Type	Photograph
4.5.1	Local area of weathered pointing below the stone capping on the buttresses	Locally repoint in a lime based mortar	D

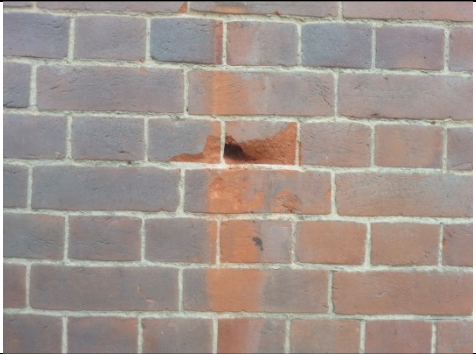
4.5.3	The bricks here have been damaged - probably due to removal of fixings	Cut out damaged brick and piece in new to match	D

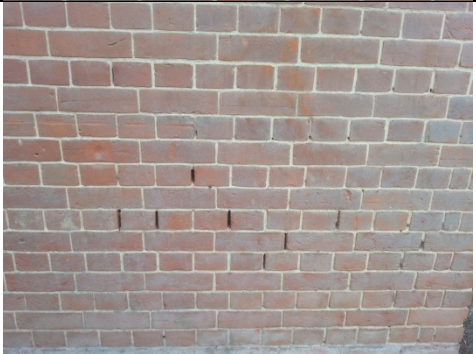
4.5.4	As 4.5.2	As 4.5.2	D

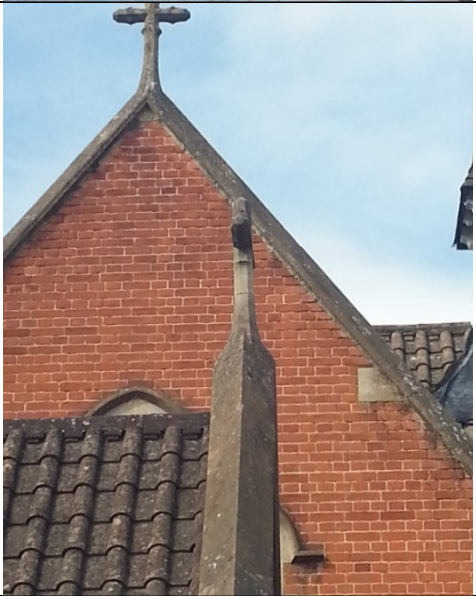
4.5.5	Generally the brick pointing is in sound condition. Here there is some minor degradation immediately below the stone gable cappings.	At time of next external renovations rake out and repoint brickwork below copings. Check copings joints are adequately pointed.	E

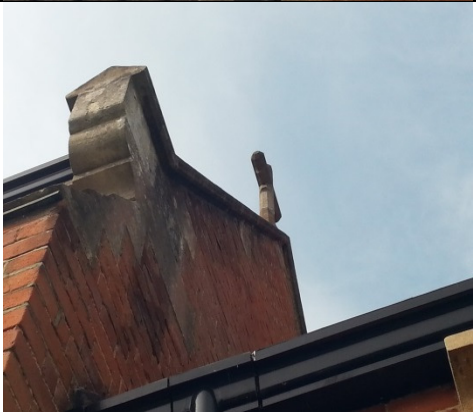
4.5.6	Staining of the brickwork due to water run-off at the base of the gable cappings.	It would be beneficial to introduce a deflector of some sort at the base of the copings to direct water onto the roof and gutter. This will reduce deterioration of the brickwork and stone corbel.	E

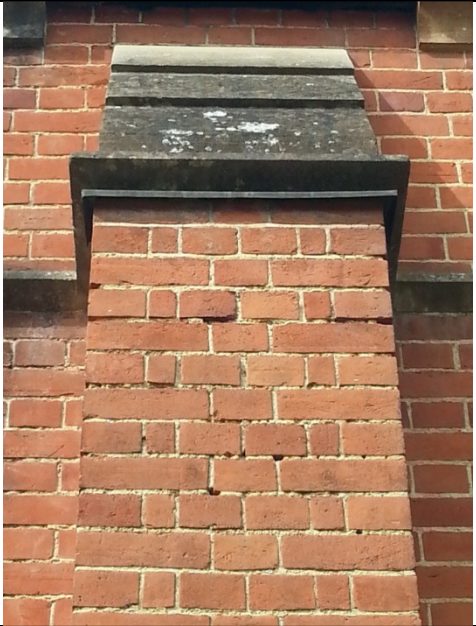
4.5.7	Weathering of the pointing below the capping stones on one of the buttresses.	As 4.5.1	D

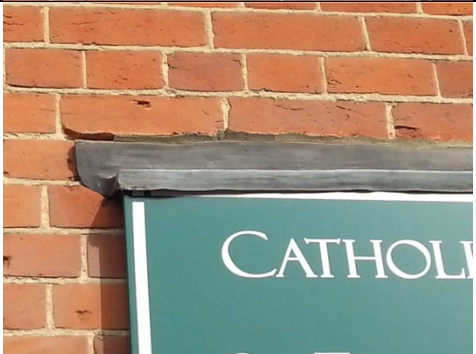
4.5.8	The pointing is missing above this lead flashing over the signage for the Church	Point in using lead sealant (not mortar)	D

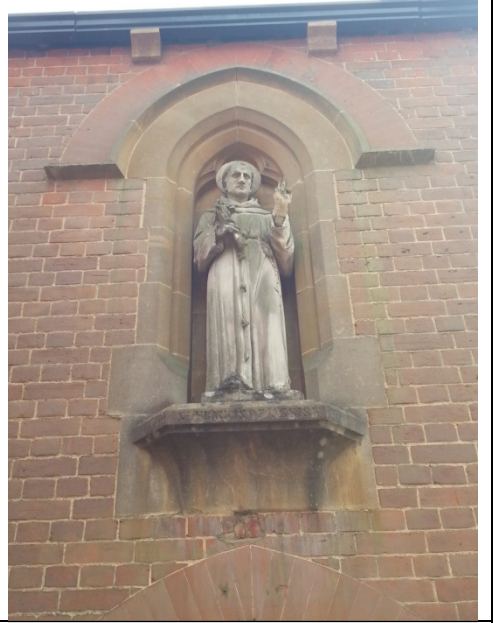
4.5.11	There is some deterioration of the stone statues, with loss of definition on the fine detail.	Plan for specialist repair within the next 15 years.	E

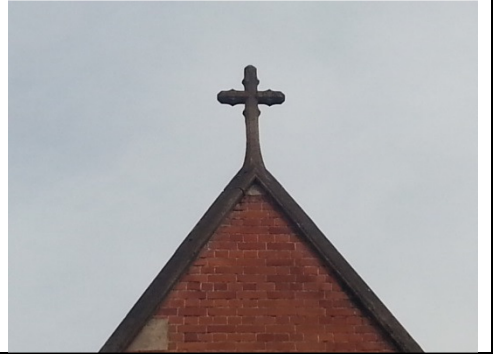
4.5.12	Main façade. Deterioration of the brick pointing below the gable cappings. The joint in the stonework has opened up, left of the cross.	As 4.5.10 And repoint the stonework.	D

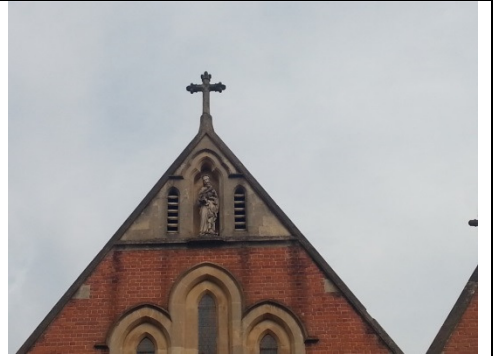
4.5.13	Main façade. Staining of the brickwork and deterioration of the pointing below the stone string and ledge - most likely through the joints in the stonework.	A lead flashing should be installed above this ledge to protect the stonework and the brickwork below. Treat any lead flashings with anti-patination oil.	D

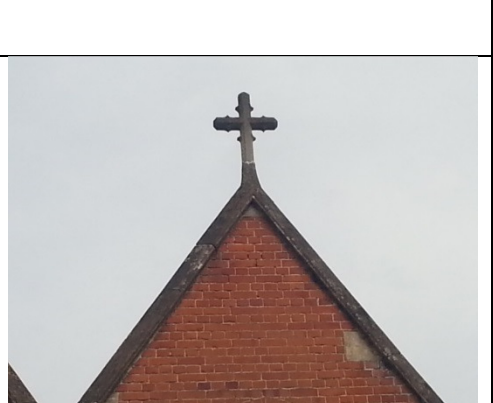
4.5.14	As 4.5.12	As 4.5.12	D

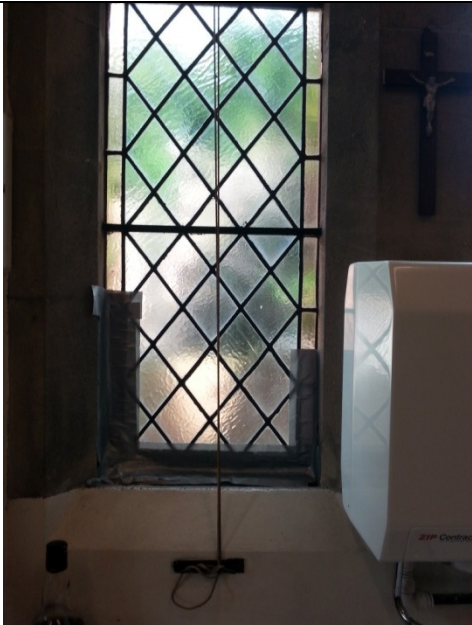
No.	Condition	Repair Need	Repair Type	Photograph
4.9.1	Sacristy window. There have been some temporary repairs to the lower lights of this unit. Overall there are 6 cracked panes, and one assembly which is bowing.	Repair fractured glass units.	D

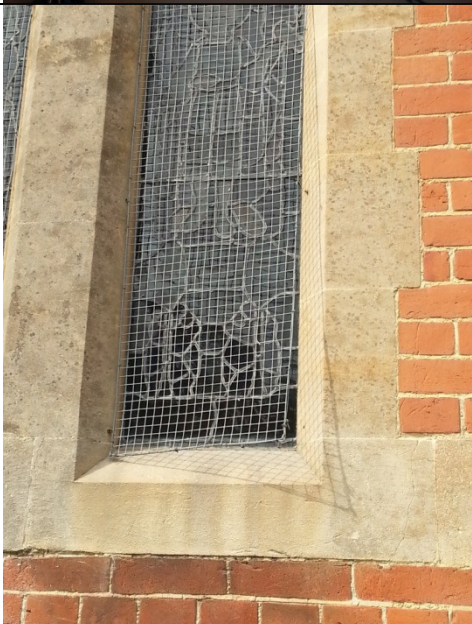
4.9.2	One of the fixings for this window grill has become loose	Re-fix	B

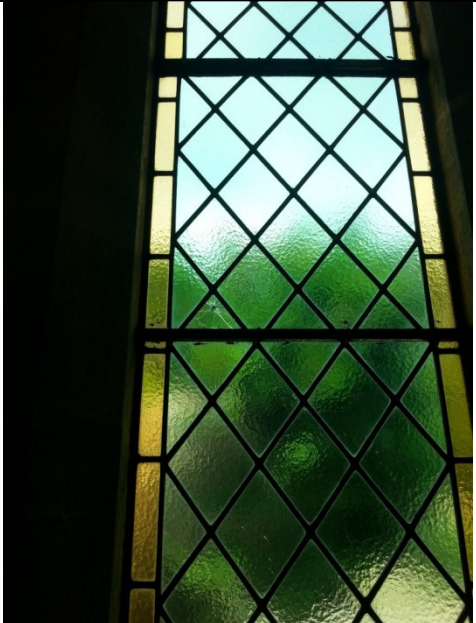
4.9.3	Cracked pane	Replace damaged glass.	E

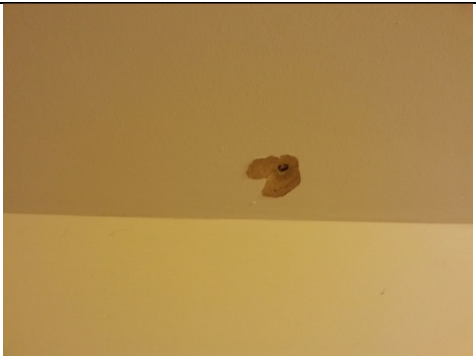
No.	Condition	Repair Need	Repair Type	Photograph
4.11.1	Blown plaster over a plasterboard tack.	Locally cut out, prime, fill, and touch in decorations.	C

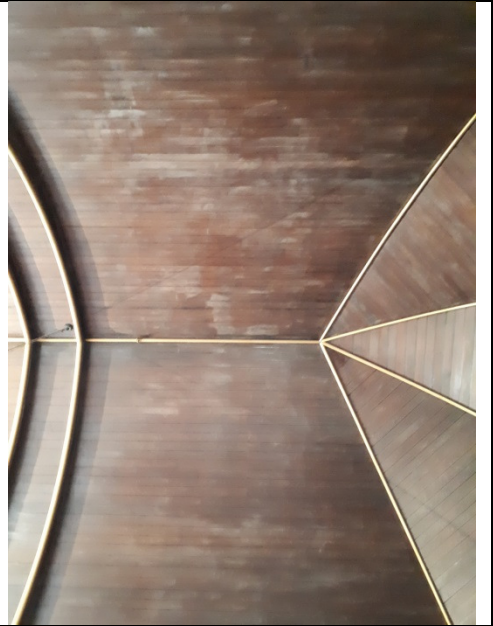
My attention was drawn to an apparent deterioration of the varnished finish to the boarded ceilings above the Monks' chapel. This is sporadic but quite extensive. The varnish has not been renewed for many years. I checked again the pitched roofs and flashings above this ceiling through high powered binoculars and could find no roofing defect which could lead to water ingress onto the concealed top surface of the timber cladding, and indeed the pattern of the discolouration does not reflect damage through water ingress. It is not possible to safely access the ceiling without the use of a mobile tower and to investigate further it will be necessary to be able to touch and see the surface close up, and take samples for analysis. My preliminary opinion is that the discolouration is most likely some form of 'blooming' of the varnish caused by a change in the internal environmental conditions, and probably an indication of condensation forming on the surface.

4.11.3	As 4.11.2	As 4.11.2	C E

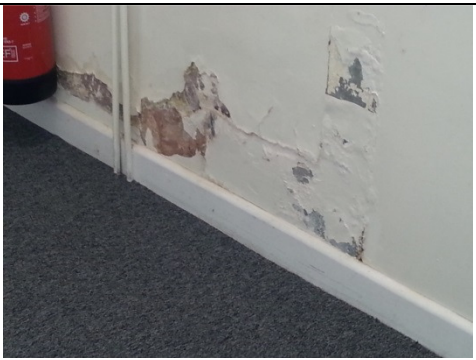
In particular by the Reception entrance, damp seems to be still occurring at low level affecting plaster and decorations where the original doorway has been in filled on the West elevation. This is also occurring to the south side of the doorway. This is most likely a defect of the dpc work undertaken at the time of the infilling and cutting through for the new entrance, exacerbated by the inadequate arrangement for draining the water from the Porch roof. Work has been undertaken to address this with limited success. Refer to Section 6.

No.	Condition	Repair Need	Repair Type	Photograph
4.12.1	Reception wall - damp affected plaster at low level. This may be due to accumulation of salts consequent of previous damp penetration. Refer also to section 6.6.	Undertake further work to check and rectify the damp proof course and to redirect the drainage from the porch roof. Then hack off the affected plaster and renew in renovating plaster.	D

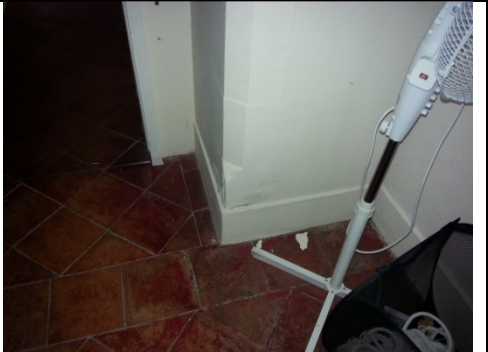
4.12.5	Sacristy corridor. Damaged plaster at low level	Repair and decorate	E

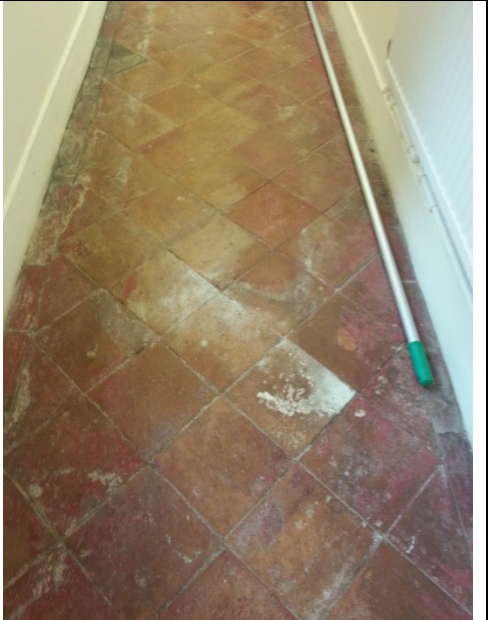
No.	Condition	Repair Need	Repair Type	Photograph
4.13.1	The quarry tiles in the Sacristy corridor.	Consider renovating the quarry tiles and repointing.	E

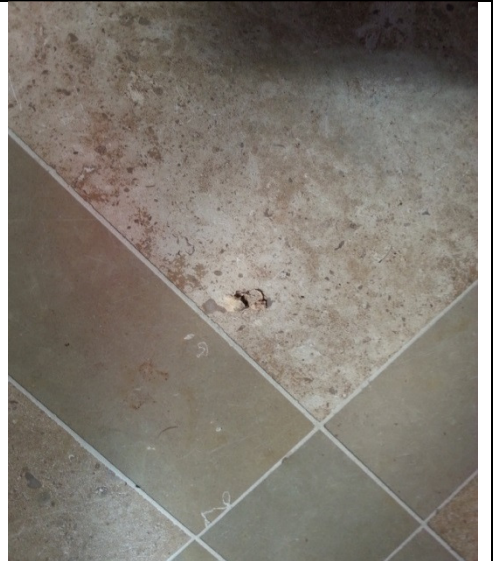
4.13.2	The limestone flooring in the Church. There has been some loss of fill within the individual slabs - I noted 5 locations.	Whilst these can be filled with a fine stone/mortar mix this is not essential; this is part of the natural wear of a soft limestone flooring.	-

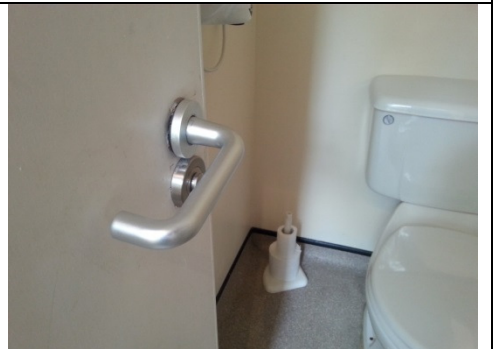
No.	Condition	Repair Need	Repair Type	Photograph
4.15.1	The ironmongery to this toilet door is loose.	Re-fix; may require improved fixings	B

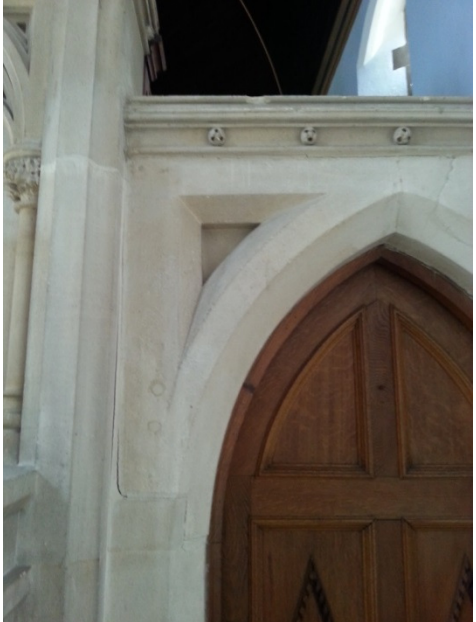
Internal stonework and stone features are sound. Fracturing has occurred at the heads of the arches to the reredos either side of the altar and this has developed since the flooring replacement works. This has been subject to monitoring by a structural engineer who advises the displacement has not been progressing during the last 18 month period.

No.	Condition	Repair Need	Repair Type	Photograph
4.17.1	The stone archway through to the Monks Chapel. The slender stonework has fractured, most likely due to differential movement between the Altar base and the foundations supporting the external walls.	The structural engineer advises that this movement is historic and monitoring indicates that it is not progressive. Consider specialist stone repairs to the fractures, which would ideally use a flexible lime based grout.	D

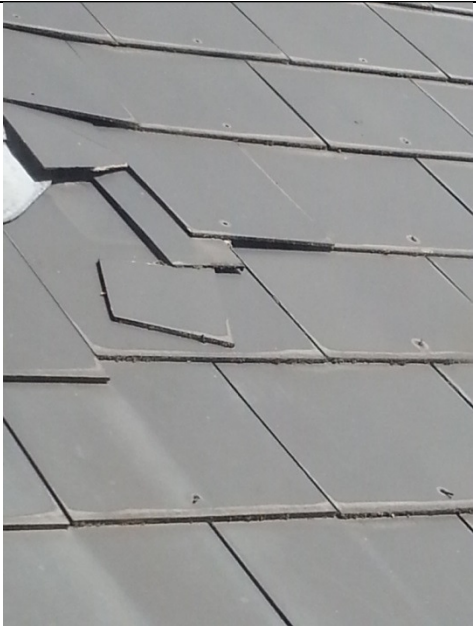
No.	Condition	Repair Need	Repair Type	Photograph
5.1.1	Meeting Rooms roof. A local area of slipped slates noted.	Re-fix into position.	B

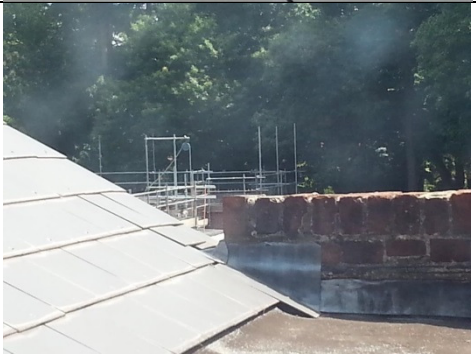
5.1.2	Meeting Rooms roof. Further area of slipped slates.	As 5.1.1	B

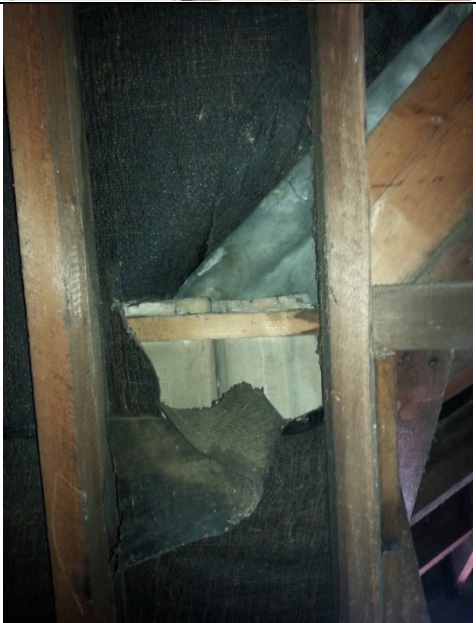
5.1.3	Friary roof void. Area of torn felt below the valley.	No water ingress occurring. This is difficult to repair without opening up from above. Keep under review.	M

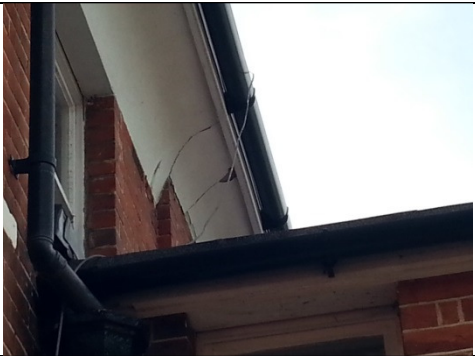
5.4.2	Eaves of the Friary. Some deterioration of the lathe and render.	Cut out and locally repair in a lime based render to match.	E

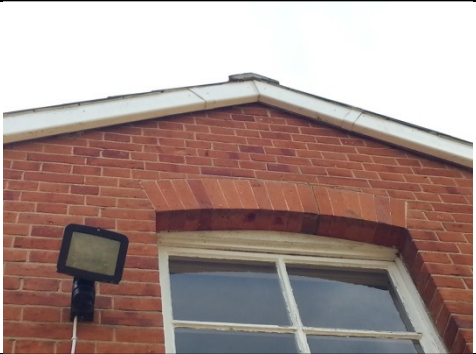
5.5.2	Meeting rooms building - brickwork fractures and slipped arch.	On the basis this building has a limited life span we advise it be kept under review.	M

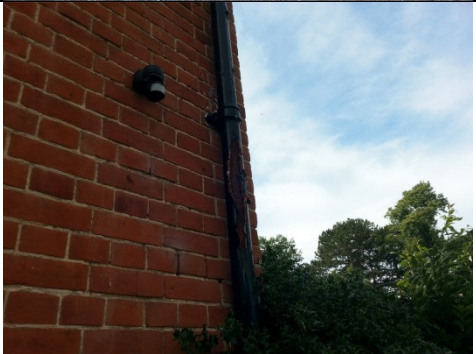
5.5.7	Early indications of corrosion of this downpipe	Renew downpipe	E

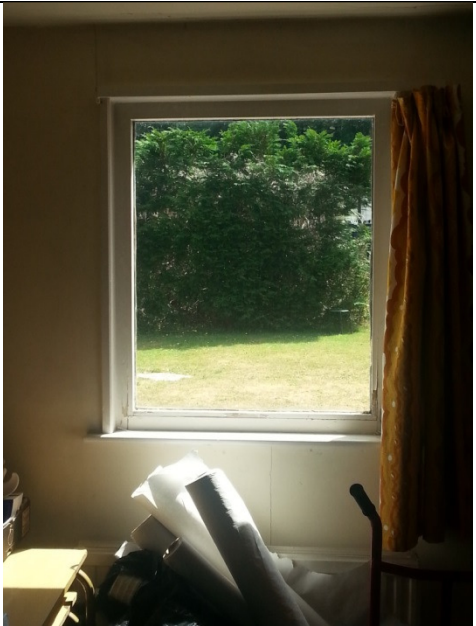
No.	Condition	Repair Need	Repair Type	Photograph
5.8.1	Single glazed low grade window, ground floor of the meeting rooms building.	Consider replacement.	E

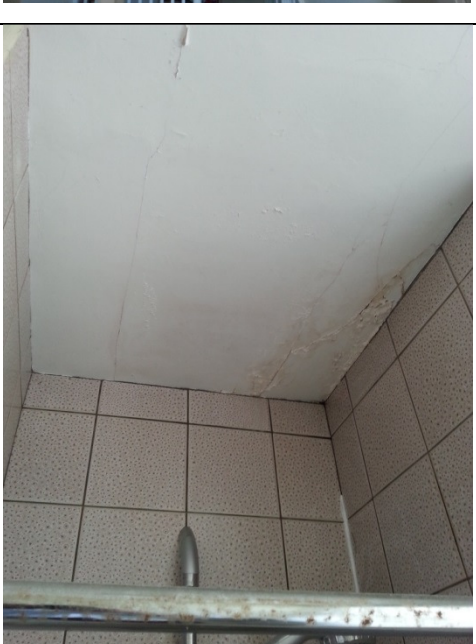
5.10.5	Localised ceiling fracture, and some old water staining, in one of the bedrooms.	Cut out locally and repair at time of next decorations.	E

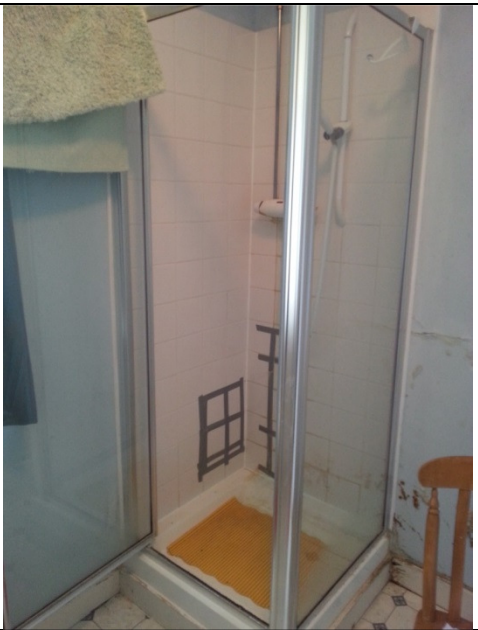
5.16.2	Bathroom 2 - plumbing leak - presumed to have been repaired.	During refurbishment of this room allow to hack off the plaster and repair in render prior to tiling.	C

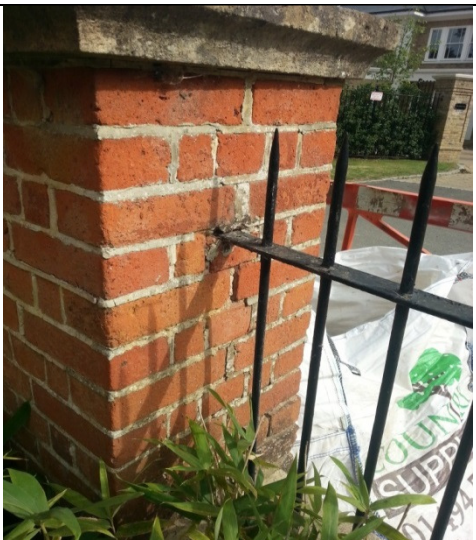
6.1.4	The 1.8m high boundary wall along Friary Close. This is stable but has a number of fractures and defective areas of brickwork.	Locally cut out raking fractures and re-point in a lime based mortar to allow for movement.	E

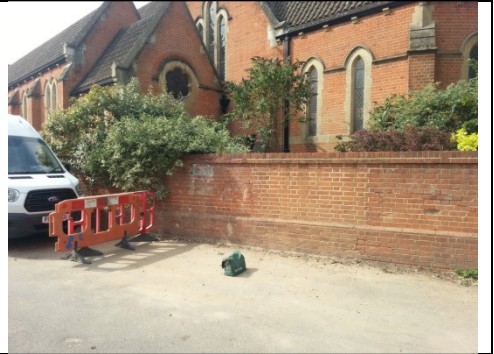
6.1.5	Some repointing of the coping bricks is required.	Local repointing in a suitable lime based mortar.	C

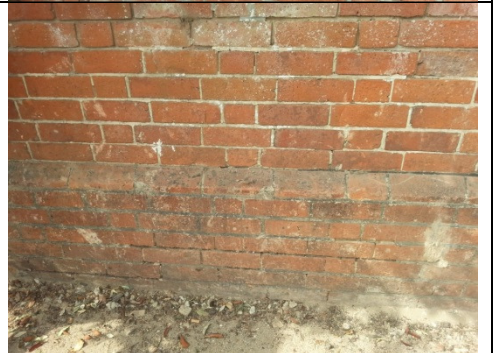
6.1.7	A typical raking vertical fracture.	As 6.1.4	E

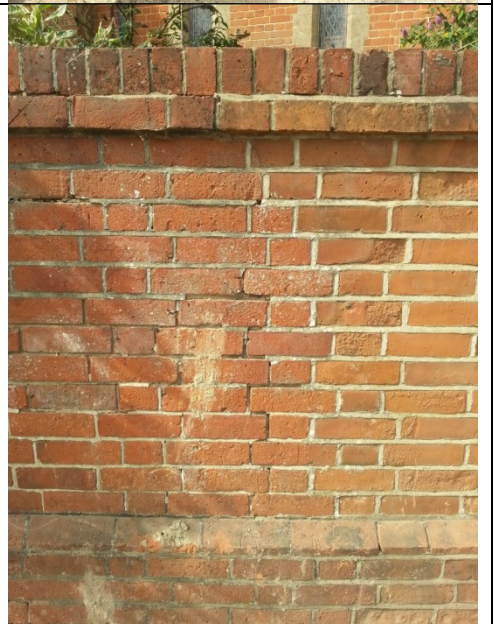
6.1.8	Areas of loss of pointing. An isolated brick has softened and spalled.	Cut out the spalled brick and replace. Local areas of repointing.	E

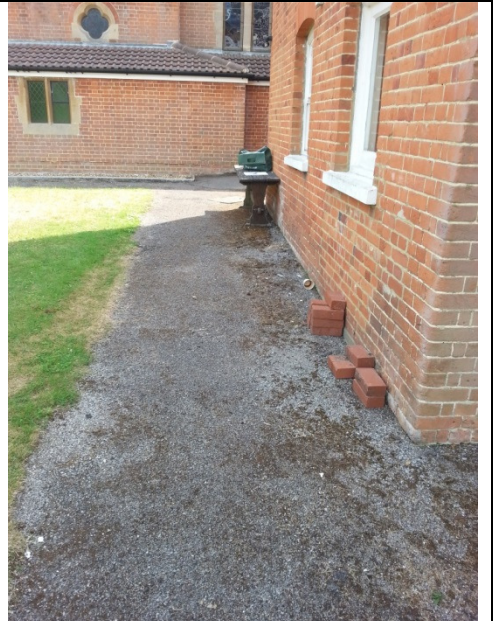
6.3.2	Macadam path within the Friary garden. The wearing course is starting to fail and the lack of edges is leading to breaking up of the macadam along the edges.	None at present, but budget for replacement during the next QQ period.	E

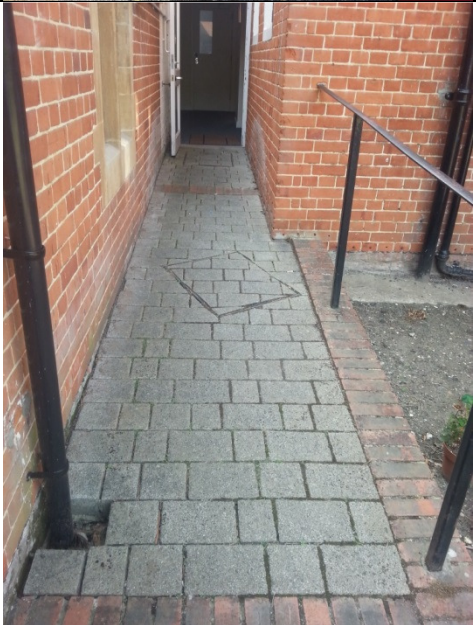
6.3.4	Since the last QQ this area has been opened up for drainage repairs.	Ensure levels are reduced to below dpc and internal floor level. Consider finishing in a permeable surface.	E

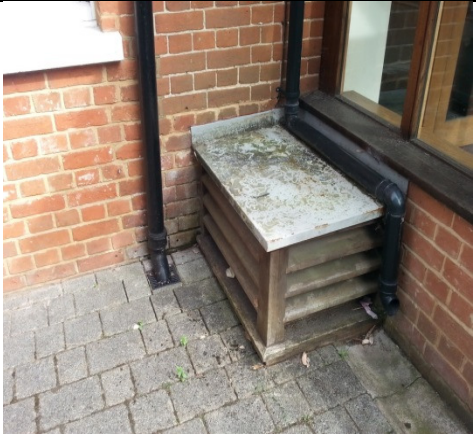
6.6.9	This is most likely a vent pipe from the main drain visible top left. It has been fractured.	Check whose responsibility this is. Repair if required.	E
