## Catholic Church of St Francis of Assisi

Coronation Road, Ascot, SL5 9HG

**Quinquennial Inspection Report** July 2017 Issue 1

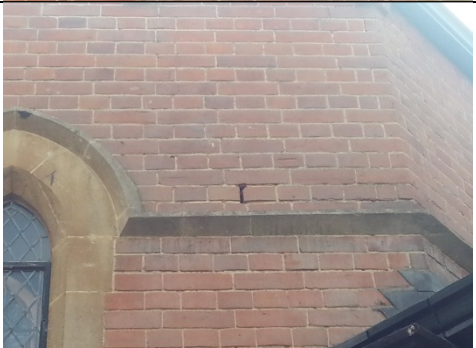
4.5.2	Local area of missing pointing on the main façade brickwork	Locally repoint in a lime based mortar	D

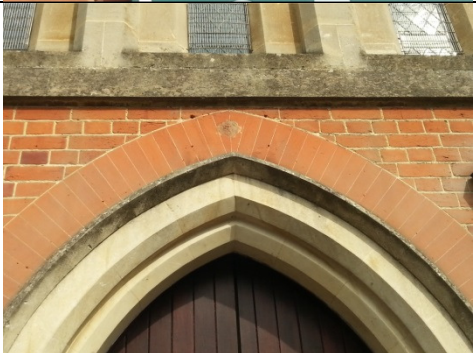
4.5.9	A fitting has been removed at the apex of this arch, leaving holes and damaged to the bricks.	Carefully repair in a colour matched mortar.	E

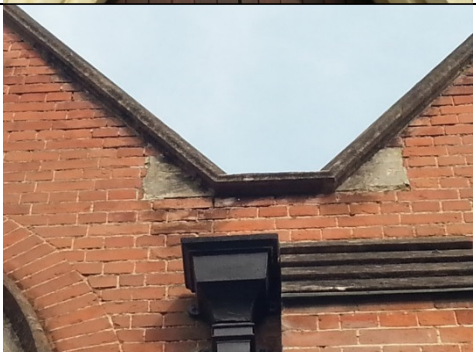
4.5.10	Localised loss of mortar pointing below the cappings at this valley location.	Rake out and repoint. Check the joints in the copings are adequately pointed to protect the brickwork below.	D

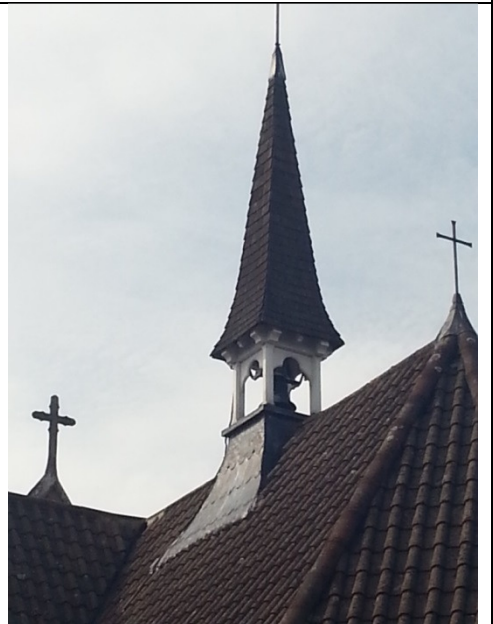
The bell tower is of timber construction with a steeply pitched tiled and lead work roof, and painted lead work apron. A detailed inspection through high powered binoculars did not indicate any signs of deterioration of the timberwork or roofing. The tower shows no significant sign of lean; the cross and lightning protection appear sound.

No.	Condition	Repair Need	Repair Type	Photograph
4.6.1	General view of the bell tower	None identified	-

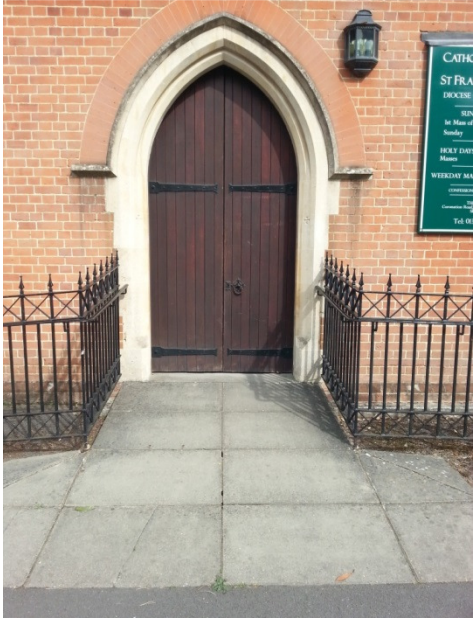
No.	Condition	Repair Need	Repair Type	Photograph
4.10.1	Entrance doors into the main vestibule	none	-

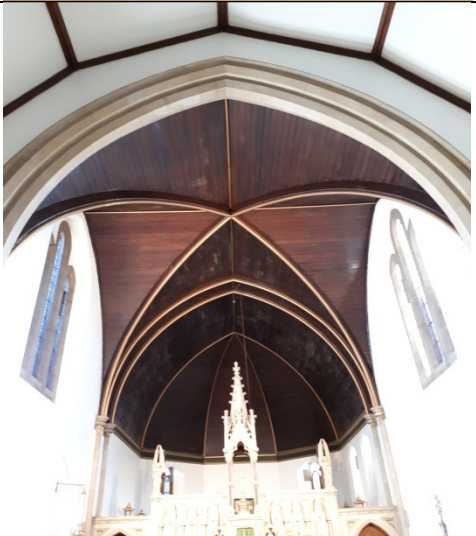
My attention was drawn to an apparent deterioration of the varnished finish to the boarded ceilings above the Monks' chapel. This is sporadic but quite extensive. The varnish has not been renewed for many years. I checked again the pitched roofs and flashings above this ceiling through high powered binoculars and could find no roofing defect which could lead to water ingress onto the concealed top surface of the timber cladding, and indeed the pattern of the discolouration does not reflect damage through water ingress. It is not possible to safely access the ceiling without the use of a mobile tower and to investigate further it will be necessary to be able to touch and see the surface close up, and take samples for analysis. My preliminary opinion is that the discolouration is most likely some form of 'blooming' of the varnish caused by a change in the internal environmental conditions, and probably an indication of condensation forming on the surface.

4.11.2	Monks Chapel ceiling - discolouration of the surface of the varnish on the timber boarding	Provide safe access for close-up inspection and sampling. Allow for comprehensive clean, preparation, and over-coating.	C E

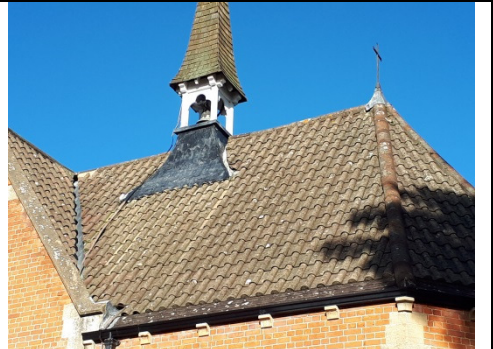
4.11.4	The roof above the Monks Chapel - no defects evident	None	-

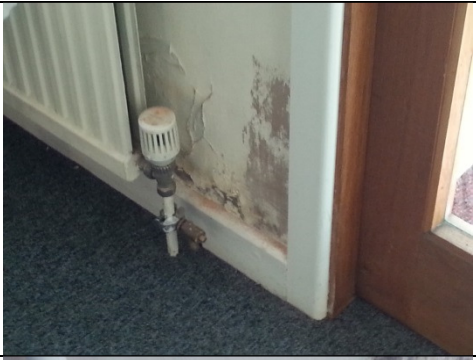
No.	Condition	Repair Need	Repair Type	Photograph
4.12.1	Reception wall - damp affected plaster at low level. This may be due to accumulation of salts consequent of previous damp penetration. Refer also to section 6.6.	Undertake further work to check and rectify the damp proof course and to redirect the drainage from the porch roof. Then hack off the affected plaster and renew in renovating plaster.	D

4.12.2	As 4.12.1	As 4.12.1	D

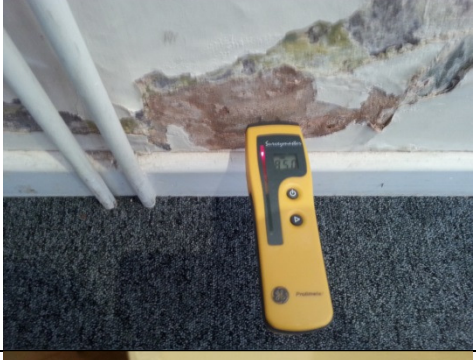
4.12.3	As 4.12.1	As 4.12.1	D

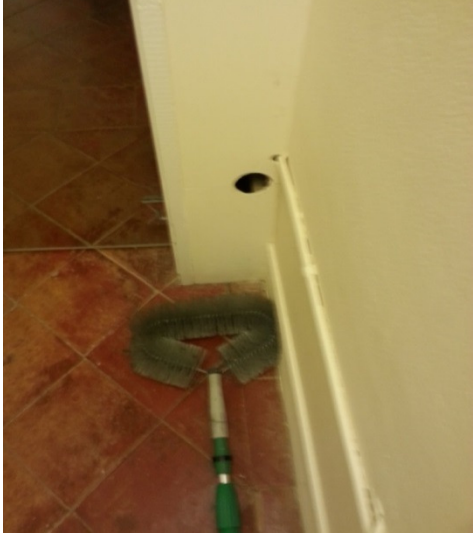
4.12.4	Sacristy corridor. Residual pipe hole following recent improvement works.	Fill and decorate	E

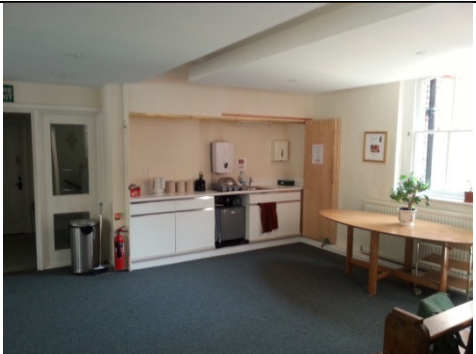
No.	Condition	Repair Need	Repair Type	Photograph
4.16.1	The tea and coffee area fittings within the main reception area.	None	-

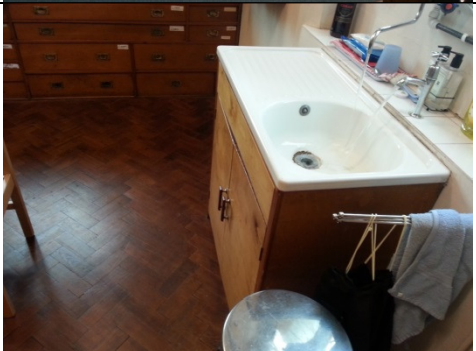
The Sacramentarium is aged and with rusting around the outlet. Consideration should be given to its replacement in due course.

4.16.2	The Sacramentarium within the Sacristy. Aged but in working order. So rusting round the outlet.	In fair condition but would benefit from replacement in the medium term.	E

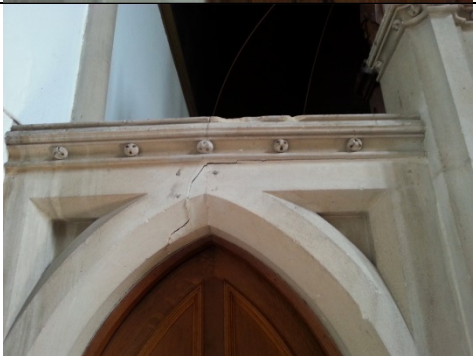
Internal stonework and stone features are sound. Fracturing has occurred at the heads of the arches to the reredos either side of the altar and this has developed since the flooring replacement works. This has been subject to monitoring by a structural engineer who advises the displacement has not been progressing during the last 18 month period.

4.17.2	As 4.17.1	As 4.17.1	D

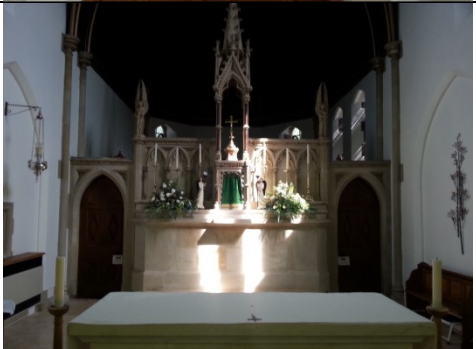
4.17.3	General view of the original Altar	None	-

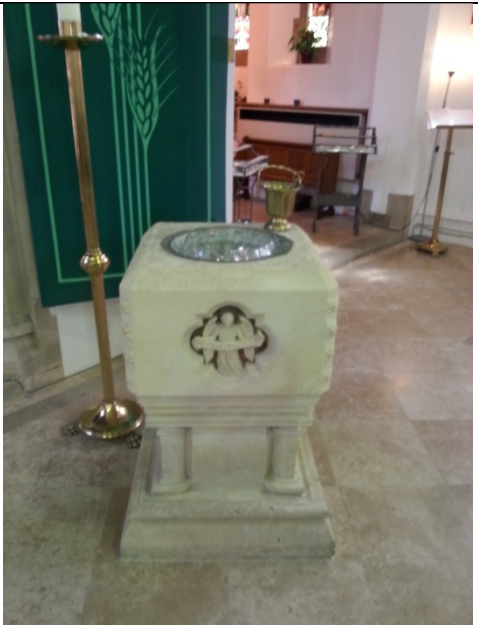
4.17.4	The Font	None

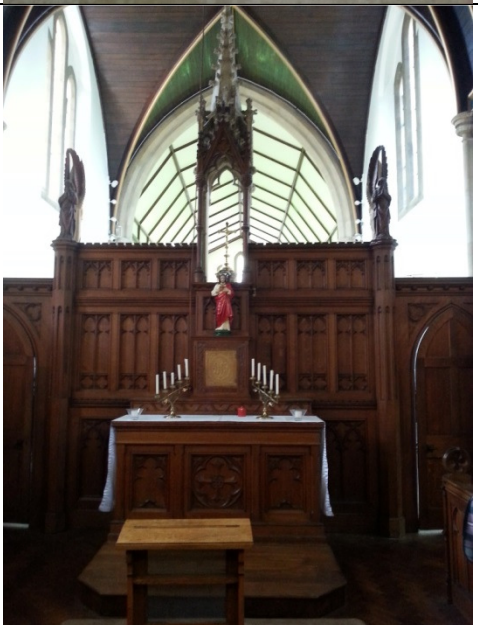
4.17.5	The Altar as seen from the Monks' Chapel	None	-

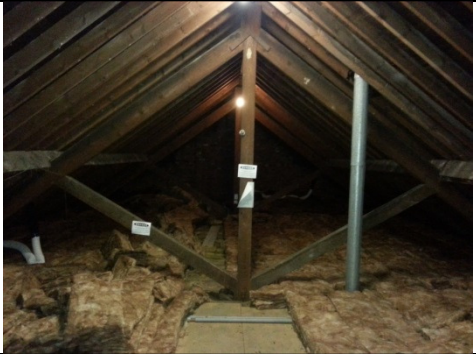
5.1.4	General view within roof void. The insulation has been disturbed leaving cold areas through the ceiling.	Set the insulation back into position.	C

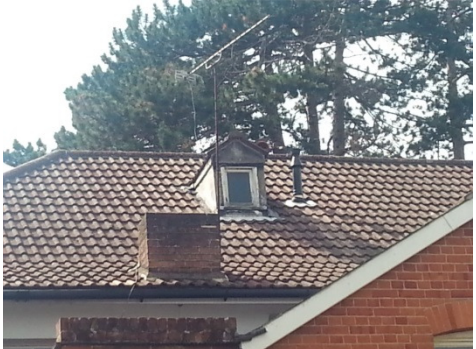
5.1.5	The rear leaded dormer and the truncated stack.	none	-

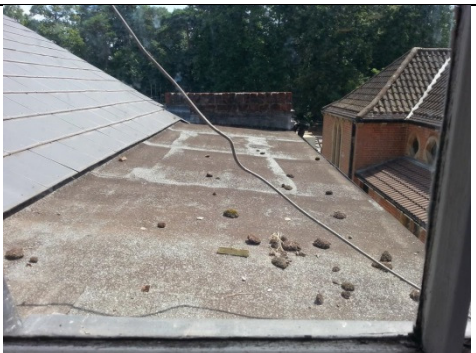
Local area of flat roof above the meeting rooms. This is aged, but in fair condition with no defects noted.

No.	Condition	Repair Need	Repair Type	Photograph
5.2.1	The flat roof over the meeting rooms	none	-

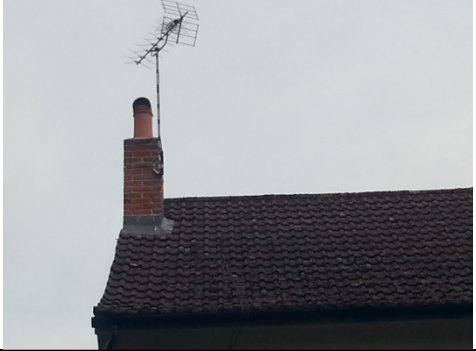
No.	Condition	Repair Need	Repair Type	Photograph
5.3.1	The gable stack has been repaired since the last QQ.	None	-

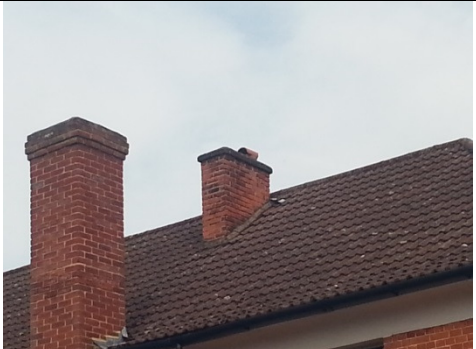
5.3.2	The two main stacks.	None	-

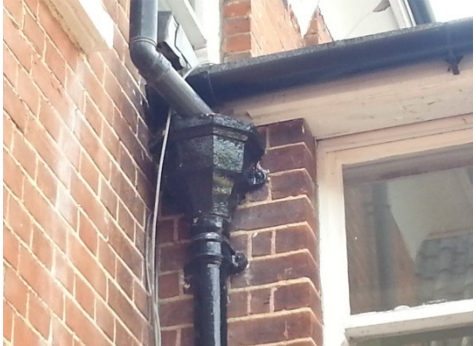
No.	Condition	Repair Need	Repair Type	Photograph
5.4.1	Hopper on the side wall of the meeting rooms. The joint requires attention.	Reform the joint at the base of the hopper	C

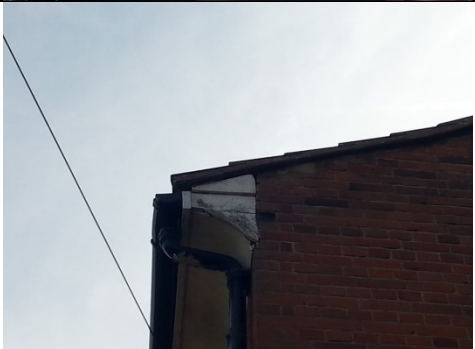
5.4.3	North end of the Friary. The timber end to the eaves has rotted and requires replacement.	Renew timber.	C

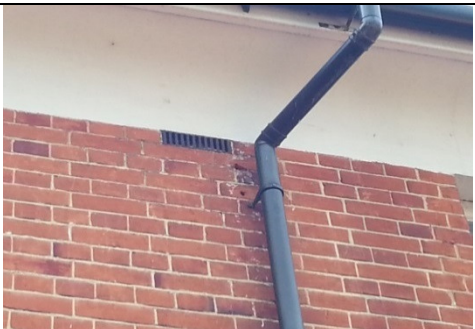
No.	Condition	Repair Need	Repair Type	Photograph
5.5.1	Redundant fixing holes in the face brickwork.	Point in a lime based mortar.	D

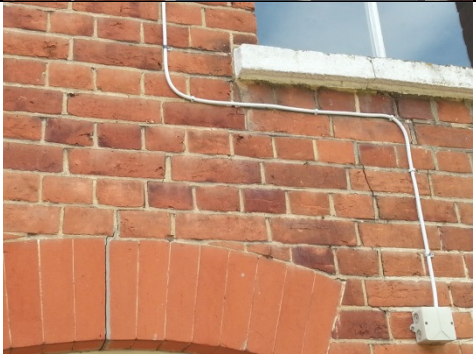
The building within the garden on the East side ('The Meeting Rooms Building'), which houses the meeting rooms, is suffering from structural movement. There are signs of fracturing to the brickwork, and there is bowing of the surface of the East elevation itself. The fracturing does not run down into the foundations, and is more indicative of the need for restraint strapping at first floor level. We note this has been recorded in the last three quinquennials, but repairs are being deferred with the intention to replace this part of the building in the future. Comparing the movement fractures against those recorded in our previous QQ inspection it does appear that there has been little or no progressive movement in the interim.

5.5.3	As 5.5.2	As 5.5.2	M

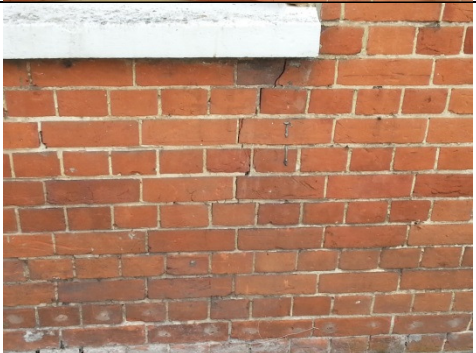
5.5.4	As 5.5.2	As 5.5.2	M

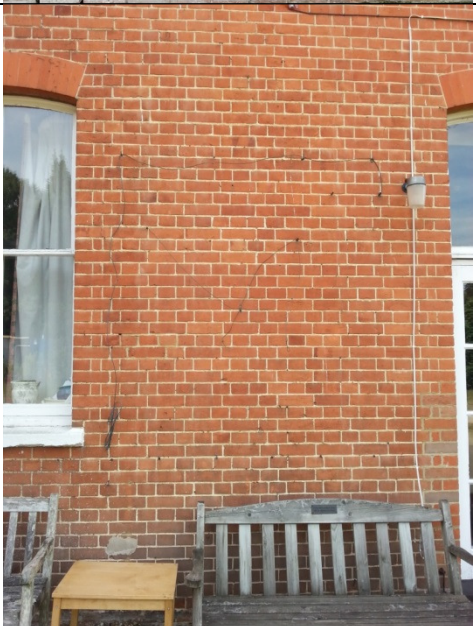
5.5.5	Redundant vine eyes on the face brickwork on the garden elevation.	Remove redundant fixings. Point in holes with lime based mortar.	E

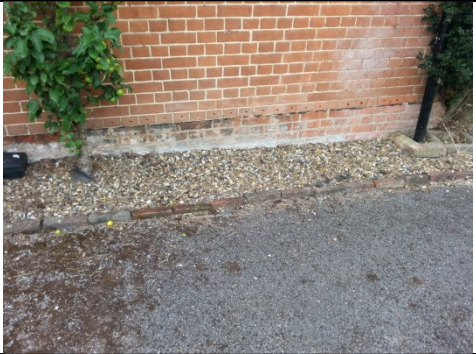
5.5.6	Indications of an injected chemical damp proof course.	None	-

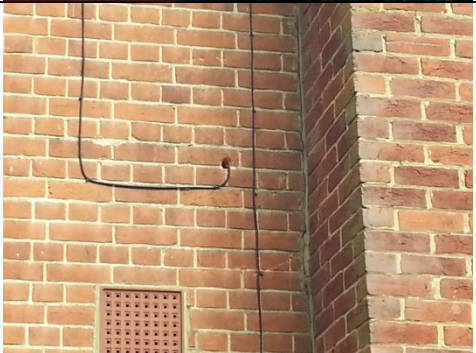
5.5.8	Hole formed by cable entry not pointed in.	Point in lime based mortar	E

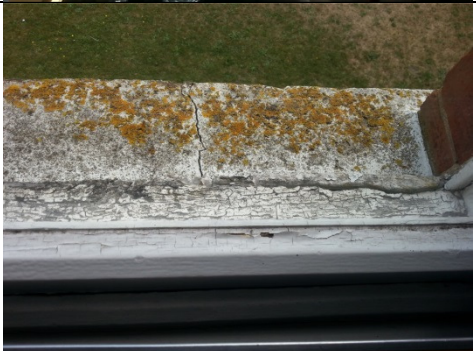
5.8.2	Fractured cill to one of the window openings of the meeting rooms building -St Clare Room.	Cut out fracture and undertake resin repair. Redecorate.	E

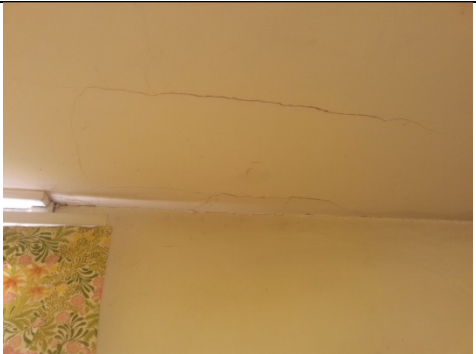
No.	Condition	Repair Need	Repair Type	Photograph
5.10.1	Meeting rooms building - ceiling fractures	Cut out and fill at time of next decoration. Consider applying a plaster skim coat to the whole ceiling	E

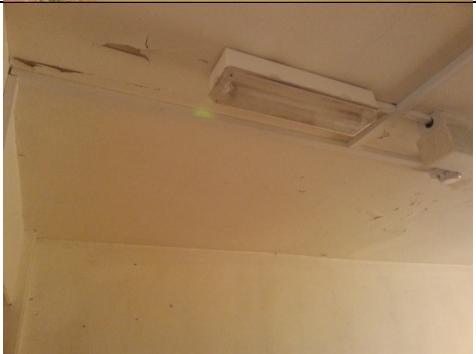
5.10.2	Meeting rooms building - flaking paintwork	Strip, make good and fill, prior to next decoration. Consider applying a plaster skim coat to the whole ceiling	E

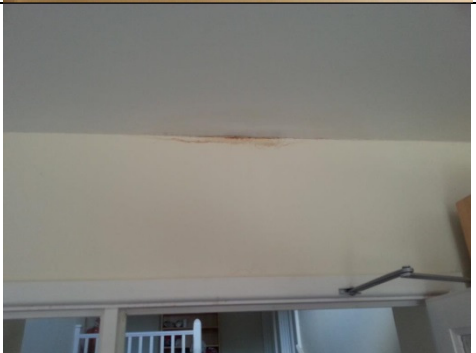
5.10.3	Local water penetration stain. This is above the staircase up to the meeting rooms. No external defect evident; this may be a stain left following a prior defect.	At time of next decoration apply stain block. If need be cut out affected plasterwork and repair.	E

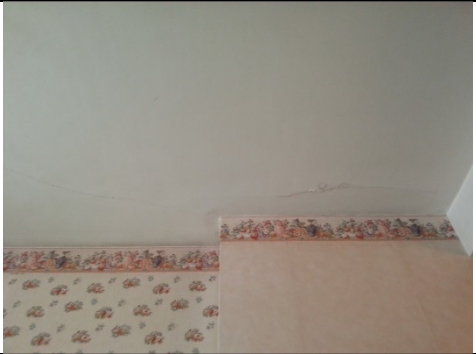
5.10.5	Localised ceiling fracture, and some old water staining, in one of the bedrooms.	Cut out locally and repair at time of next decorations.	E

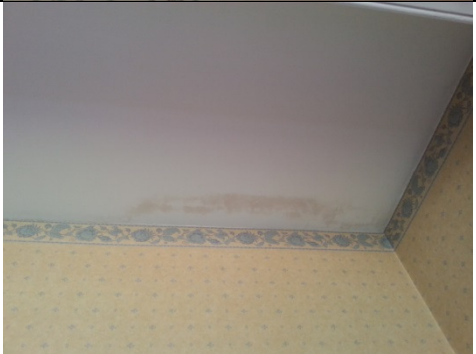
5.10.6	As 5.10.5	As 5.10.5	E

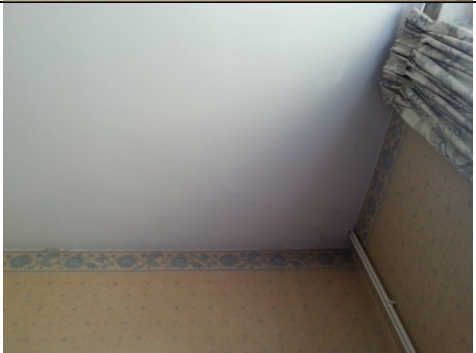
5.10.7	Hairline fractures within the lathe and plaster ceiling.	As 5.10.5	E

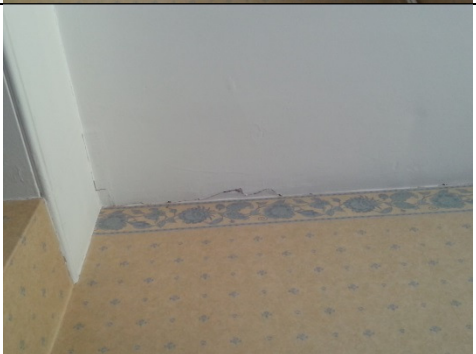
5.10.8	As 5.10.7	As 5.10.5	E

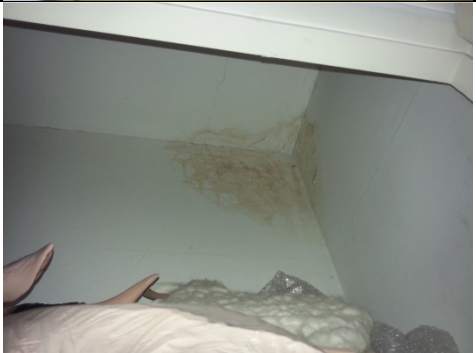
5.10.10	At high level within built in cupboard. Plasterwork affected by damp - most likely an old plumbing leak	Cut out and repair at time of next decoration. Upon cutting out, check above for any leaking pipework.	E

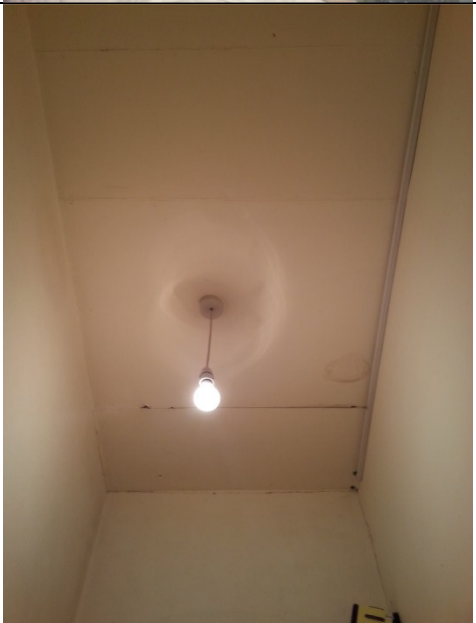
5.10.11	Ground floor corridor. Opening up of the joints between plasterboard sheets.	Cut out and fill at next decorations. Consider plaster skim.	E

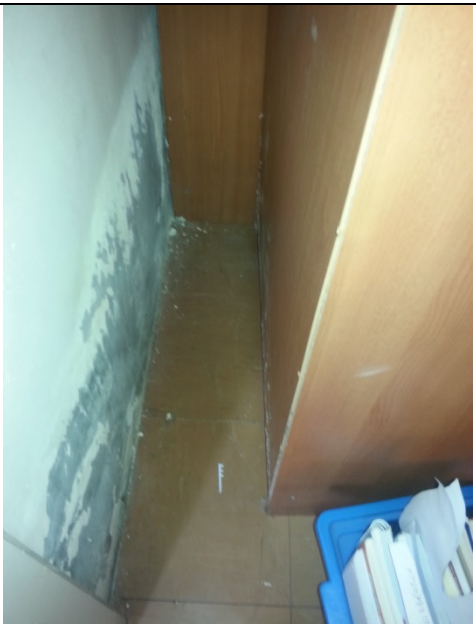
At the last QQ we reported damp readings at ground level of the meeting rooms building. I still recorded damp, though to a lesser degree. Since the last QQ repairs have been undertaken to the drainage and some, but not all, external levels reduced. If this building is to be retained long-term, then I advise that the macadam paths around it be broken out and levels reduced, consideration given to injecting a dpc (subject to more detailed and deep-penetration readings), and the affected plaster removed and replaced with a suitable renovating plaster.

No.	Condition	Repair Need	Repair Type	Photograph
5.11.1	Damp affected plaster, ground floor of the meeting rooms.	Reduce external levels. Appoint a specialist to take more detailed readings. If necessary inject a dpc. Hack off affected plaster and renew with renovating plaster.	E

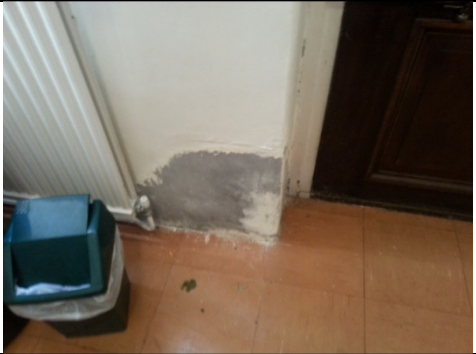
5.11.2	As 5.11.1	As 5.11.1	E

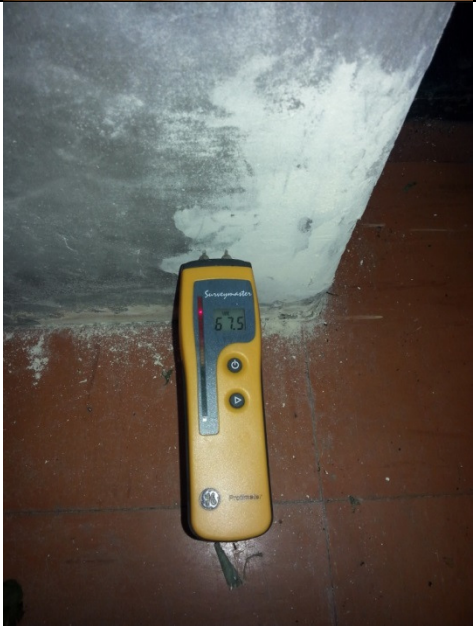
5.11.3	As 5.11.1	As 5.11.1	E

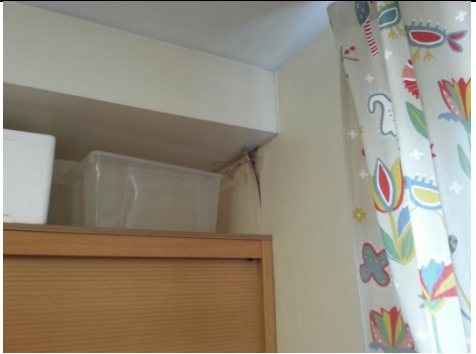
5.11.6	At high level within the St Francis room, this damp patch indicates a possible valley problem.	Access the valley, clear any build-up of debris and moss, check the valley lining. Cut out damp affected plaster, renew in renovating plaster, and redecorate.	C  E

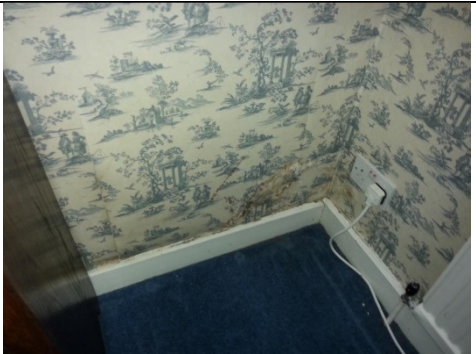
5.11.7	Damp affected wall paper at low level in the corner of this small bedroom.	This appears to be residual staining from an old plumbing leak. During next decoration strip off the paper, hack off the affected plaster and renew in renovating plaster.	E

There appears to have been a plumbing or waste leak, now rectified, which has stained the wall at low level, and is the cause of the staining in the small bedroom noted under 5.11.7.

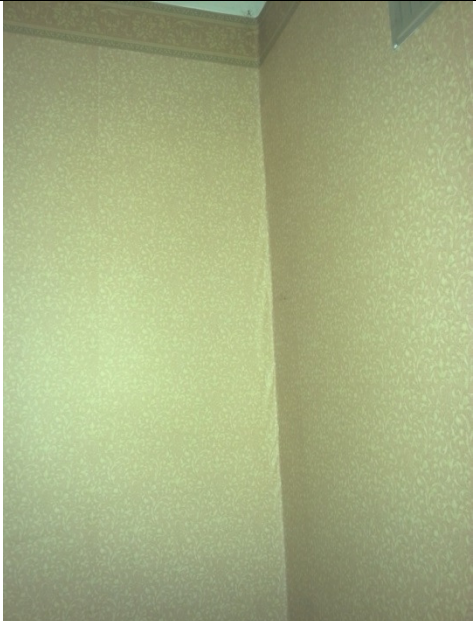
5.11.8	The rippling of the wall paper in this bedroom has not deteriorated since the previous QQ (Photo 5.13.5), indicating that any movement of the walls here has not developed further.	None	-

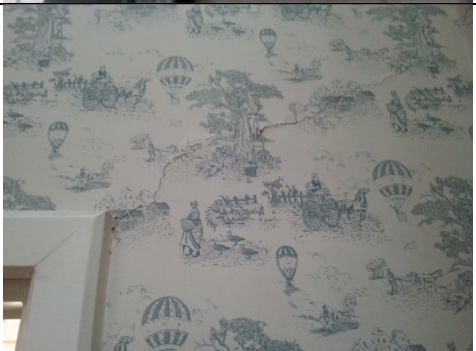
5.11.11	As 5.11.10	As 5.11.10	E

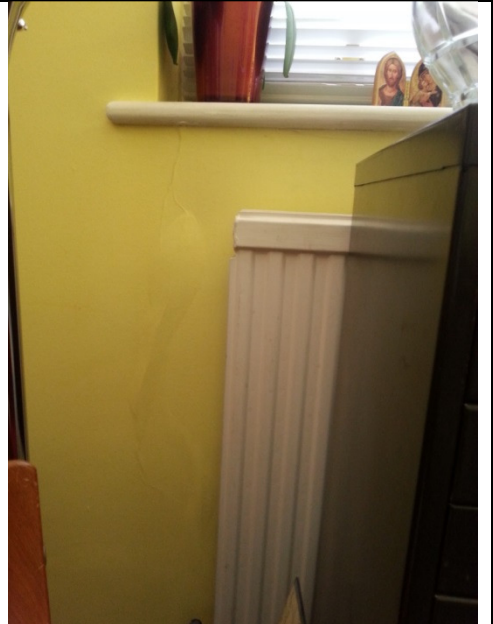
5.11.12	Area of loose plaster to the left side of this radiator.	Allow to hack off to sound plaster at the time of next decoration, and re-plaster locally.	E

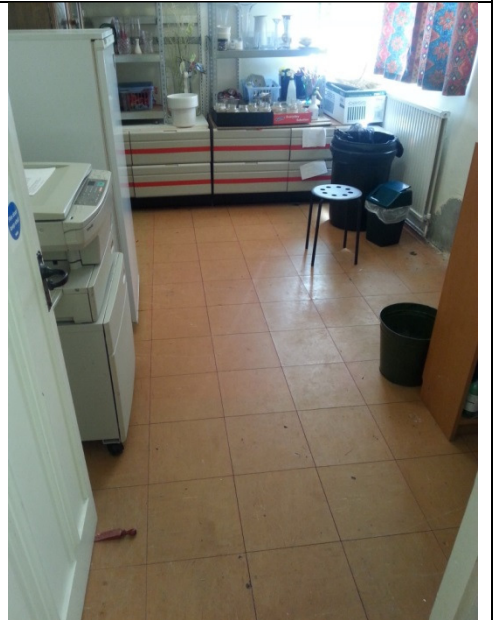
No.	Condition	Repair Need	Repair Type	Photograph
5.12.1	The vinyl tile flooring of the offices. This aged and worn. Some tiles are lost or fractured.	If this building is to be retained these should be renewed. Ensure that they are tested for any asbestos content before undertaking any work on them.	D

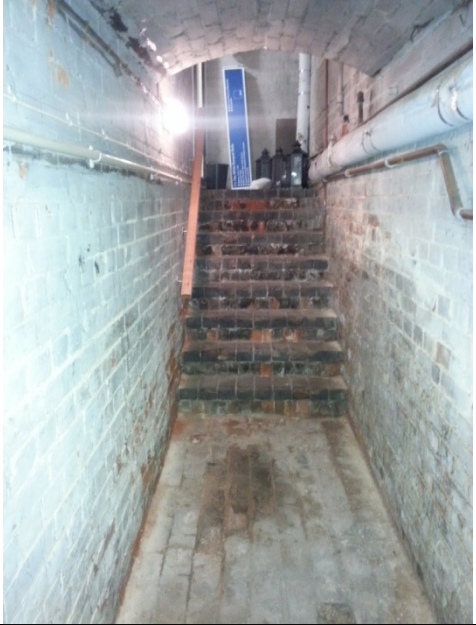
No.	Condition	Repair Need	Repair Type	Photograph
5.13.1	The brick stair leading down to the basement.	None. This is adequate for occasional and controlled use to access the basement plant rooms	-

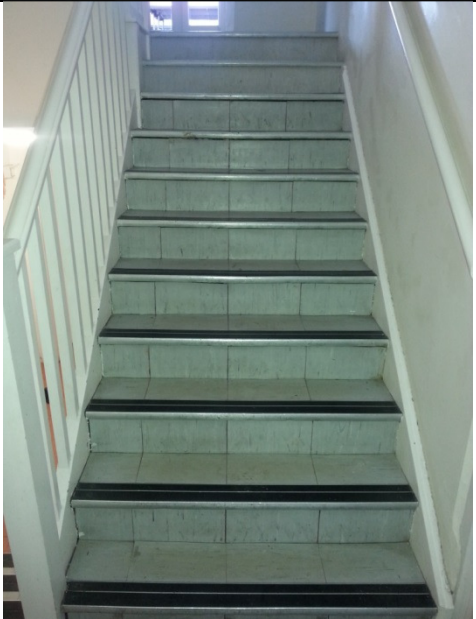
5.13.2	The stairs up to the meeting rooms and down to the offices below. These are suitable and are in good condition. There are some loose tiles which need to be bonded back into position.	Localised vinyl repairs to the treads and risers.	C

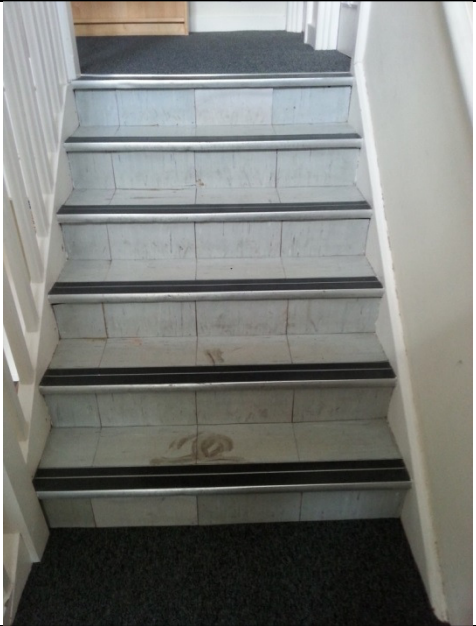
5.13.3	As 5.13.2	As 5.13.2	C

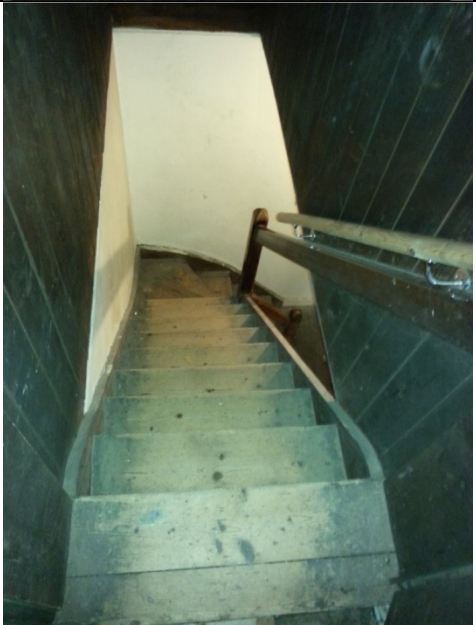
5.13.4	The steep stair up to the Friary loft. This is very steep but acceptable for occasional and controlled access to the loft area.	None	-

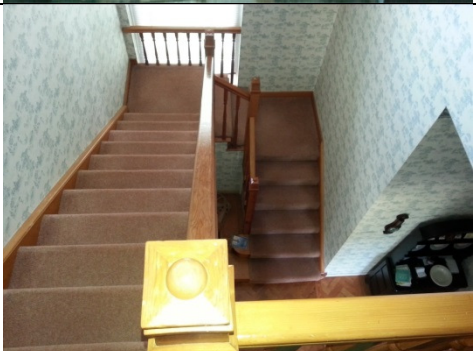
5.13.5	The main staircase within the Friary is in sound condition.	None	-

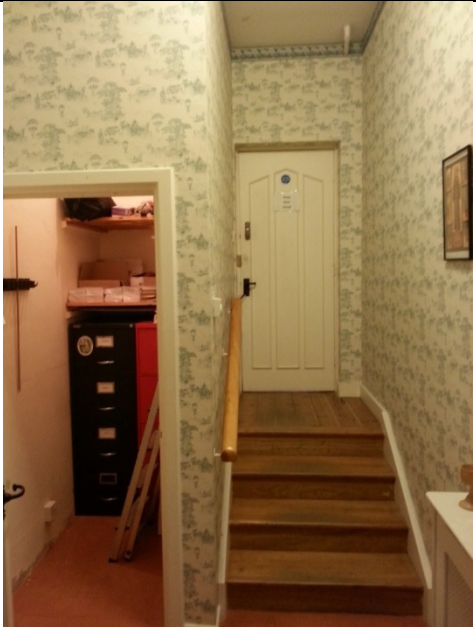
5.13.6	A short flight up from the Friary into the entrance foyer. Timber floor boards and stairs with a wall handrail one side. Consideration could be given to providing colour contrast nosings, but this would not be a requirement in a domestic residence. If this area becomes more focussed on non-domestic usage, then nosings should be added.	None at present.	-

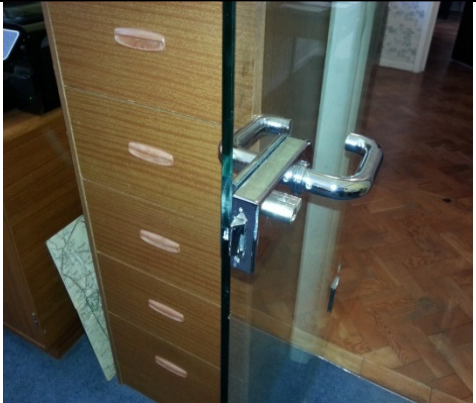
No.	Condition	Repair Need	Repair Type	Photograph
5.14.1	The door into the office has been replaced with a glass door. The ironmongery is poorly fixed and requires attention.	Check and re-fix the ironmongery.	C

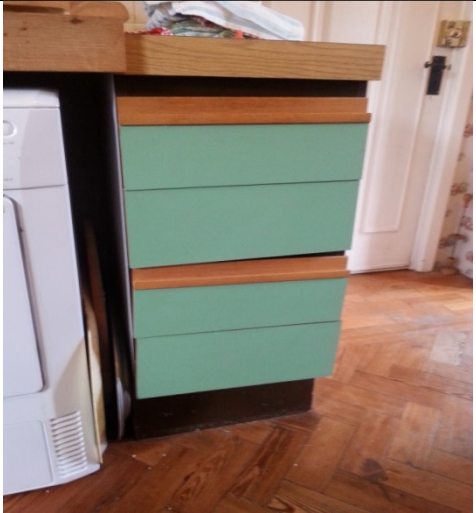
No.	Condition	Repair Need	Repair Type	Photograph
5.15.1	A number of the drawer units have become displaced and need repair.	Undertake a general overhaul of cupboard and drawer fronts.	C

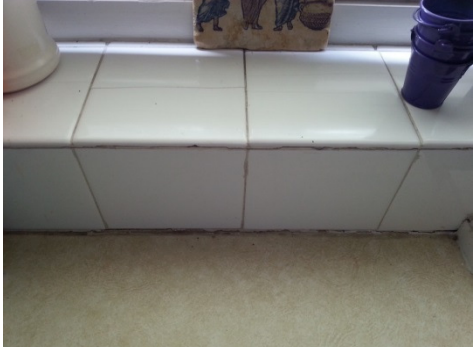
5.15.3	There are a small number of cracked wall tiles - here on the window cill.	Cut out and replace cracked tiles. Re-grout all tiles. Renew the seals along the splashback edge and around fittings.	C

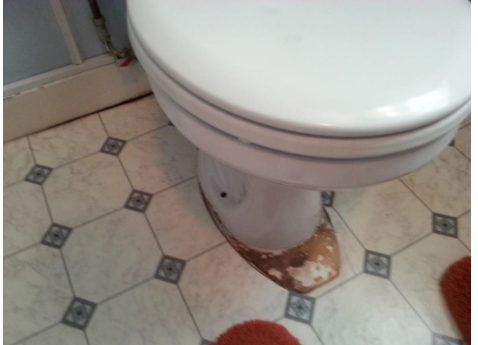
5.16.3	Bathroom 2 - poorly fitting vinyl flooring.	Replace	C

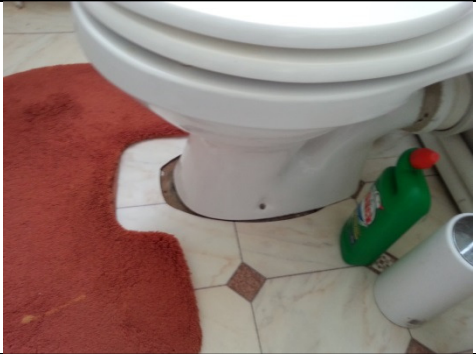
5.16.4	Bathroom 1 - poorly fitting vinyl flooring.	Replace	C

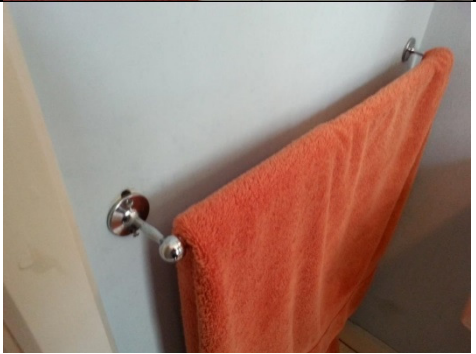
5.16.5	Bathroom 2 - the towel rail is loose	Re-fix	B

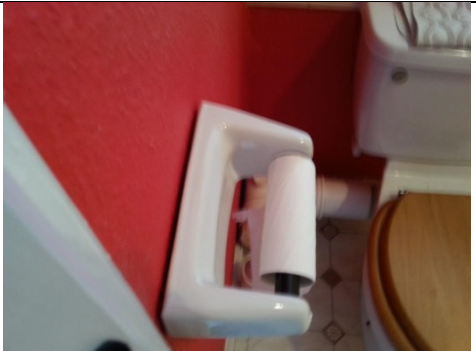
5.16.6	Bathroom 3 - toilet roll holder is loose	Re-fix	B

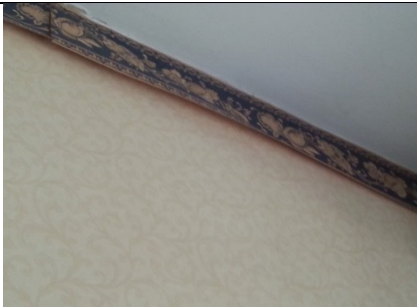
No.	Condition	Repair Need	Repair Type	Photograph
5.17.1	This wallpaper frieze, and the dado, within the Sitting Room is loose.	Remove and renew.	C

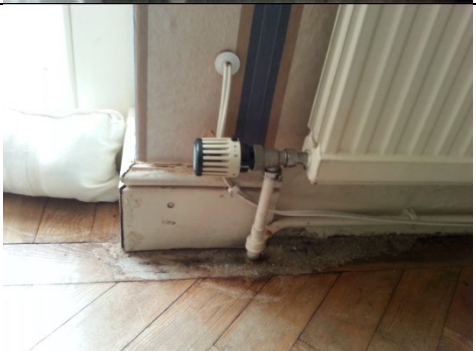
5.18.8	Friary living room. The drain down point below this radiator has a slow leak, which if left unattended could instigate a rot outbreak below the floor.	Instigate plumbing repair.	A

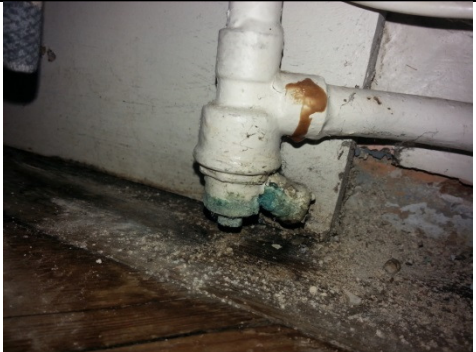
5.18.9	As 5.18.8	As 5.18.8	A

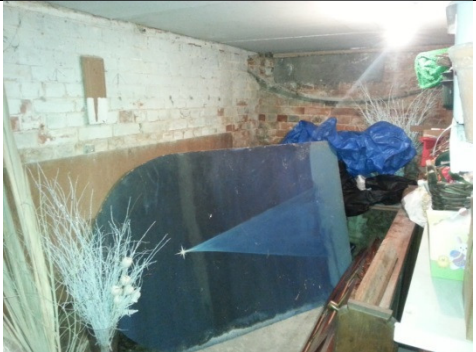
No.	Condition	Repair Need	Repair Type	Photograph
5.19.1	Flammable items are being stored within the basement adjacent the plant room. These should be removed.	Remove all stored flammable items	A

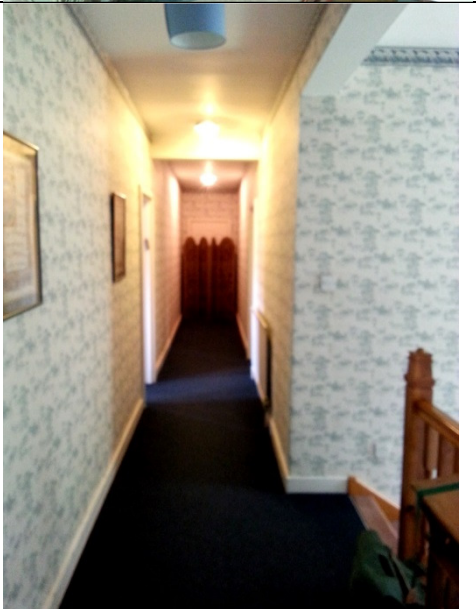
5.19.2	A mobile screen has been placed at the end of the Friary corridor.	This is the secondary escape route from the 1 <sup>st</sup> floor of the meeting rooms. It is imperative that the route be kept clear.	A

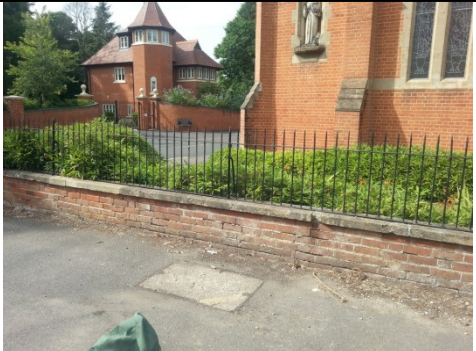
No.	Condition	Repair Need	Repair Type	Photograph
6.1.1	The side wall and railings. Repairs were undertaken following the 2012 QQ report, but some further damage has occurred subsequently.	Local minor repairs following impact damage. The brickwork requires raking out and repointing.	C

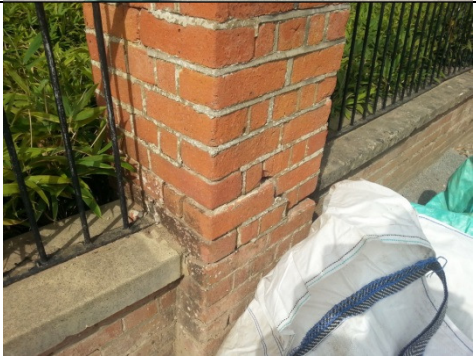
6.1.2	This pier has been hit by a vehicle; the top portion has slid on the base. The raking crack can be seen just above the tarpaulin.	It may be possible to slide the pier back into position, rake out and repoint; though this would be a limited repair. The alternative is to reconstruct it.	C

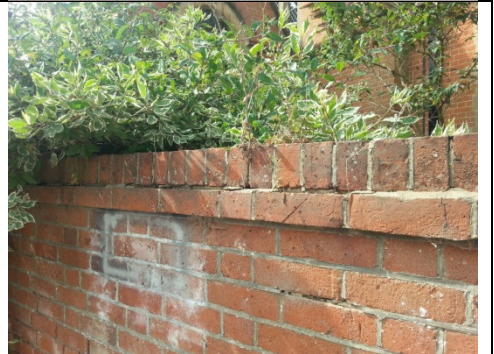
6.1.5	Some repointing of the coping bricks is required.	Local repointing in a suitable lime based mortar.	C

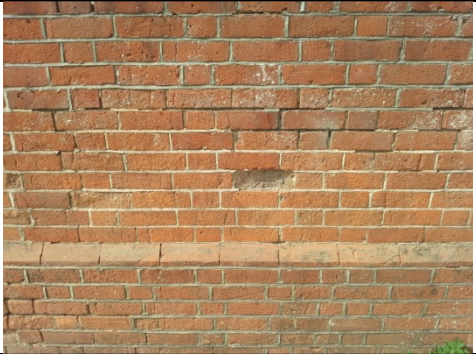
6.1.8	Areas of loss of pointing. An isolated brick has softened and spalled.	Cut out the spalled brick and replace. Local areas of repointing.	E

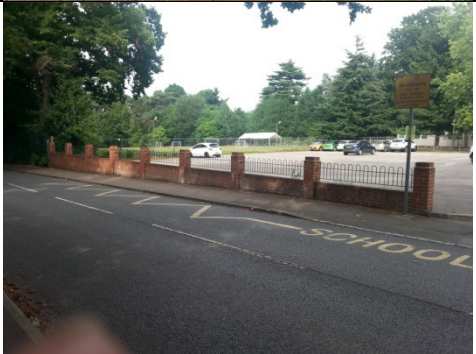
6.1.9	The boundary wall of the car park against Coronation Road. This is in good condition.	None	-

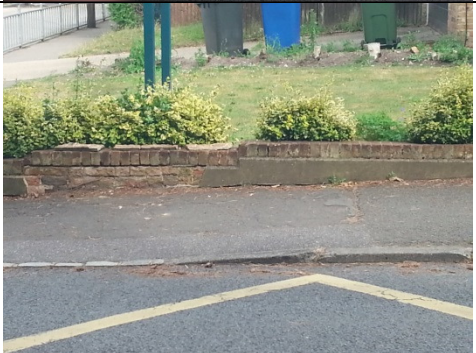
6.1.10	The dwarf boundary wall in front of the Friary. A dense render has been applied to the face onto the footpath and this is falling away, probably due to saturation and frost action.	The brickwork behind the render has lost its face and will continue to deteriorate. I do not advise rendering in this location. It will be necessary to remove the damaged brickwork to ground level and reconstruct.	D

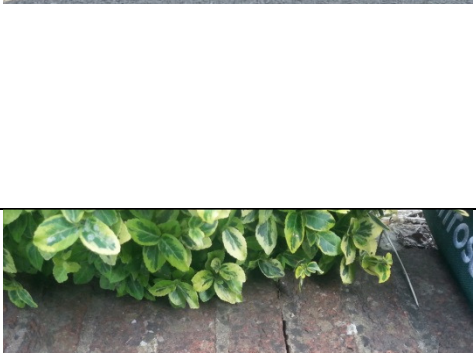
6.1.11	As 6.1.10. Here ground movement has fractured the wall.	As 6.1.10	D

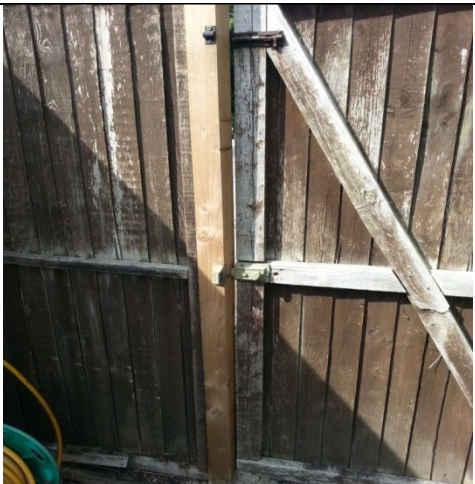
No.	Condition	Repair Need	Repair Type	Photograph
6.2.1	Timber gate into the Friary garden has dropped.	Ease and adjust.	C

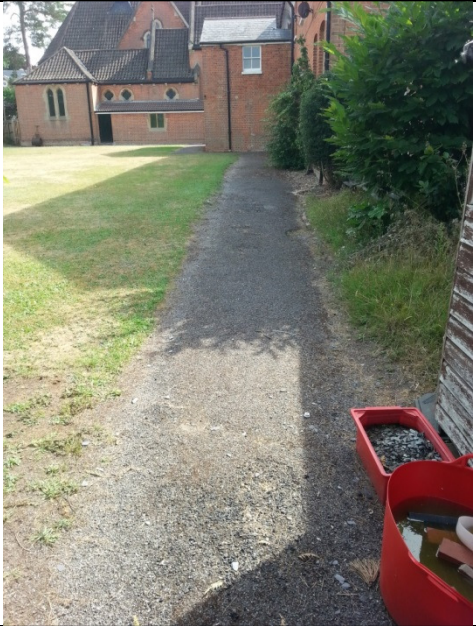
6.3.2	Macadam path within the Friary garden. The wearing course is starting to fail and the lack of edges is leading to breaking up of the macadam along the edges.	None at present, but budget for replacement during the next QQ period.	E

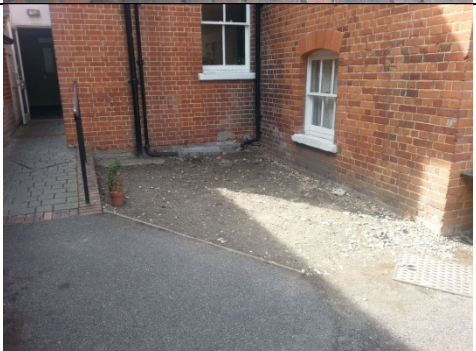
6.3.4	Since the last QQ this area has been opened up for drainage repairs.	Ensure levels are reduced to below dpc and internal floor level. Consider finishing in a permeable surface.	E

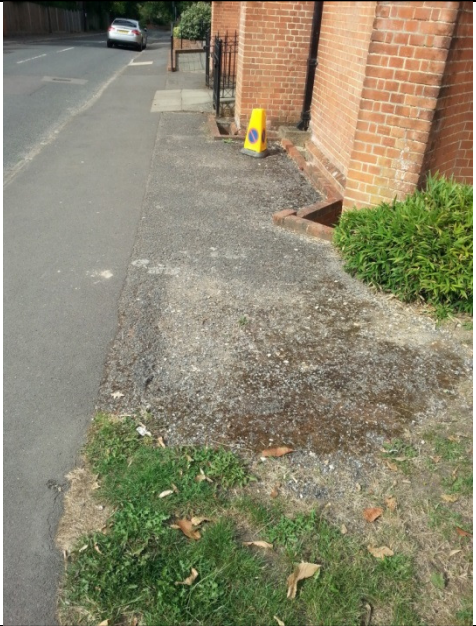
6.3.5	The small forecourt at the front of the Church. An area of macadam is breaking up, probably a consequence of being trafficked by large vehicles.	Cut out and patch in macadam, or revert to soft landscape.	D

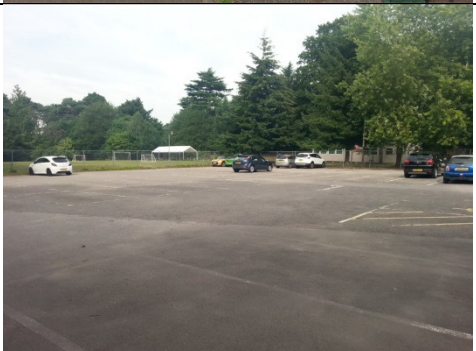
6.3.7	The car park macadam is sound.	None other than minor patch repairs as illustrated below	-

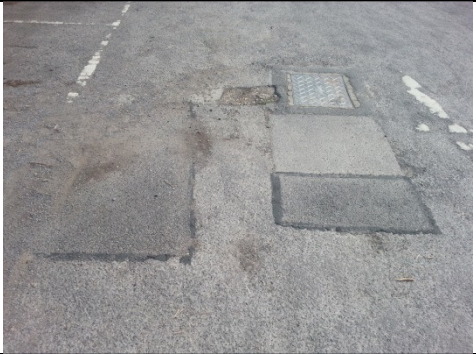
6.3.8	Patch repairs to the car park. An area to the left of the inspection chamber cover requires patching.	Cut out locally and patch.	D

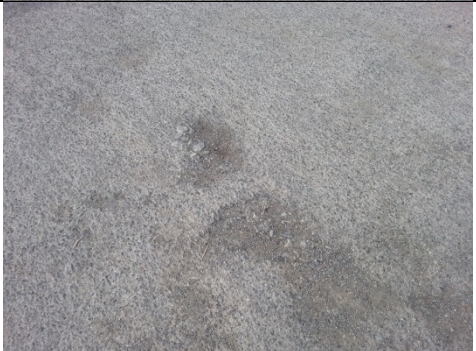
6.3.9	Local wear of the car park surface.	As 6.3.8	D

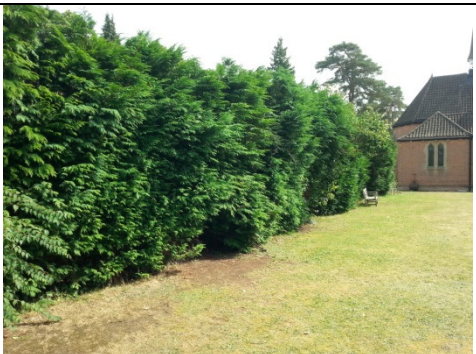
No.	Condition	Repair Need	Repair Type	Photograph
6.4.1	The rear boundary with the school has an overgrown conifer hedge.	This hedge needs to be kept under control by regular hard pruning, or to be removed to prevent it becoming a nuisance.	M

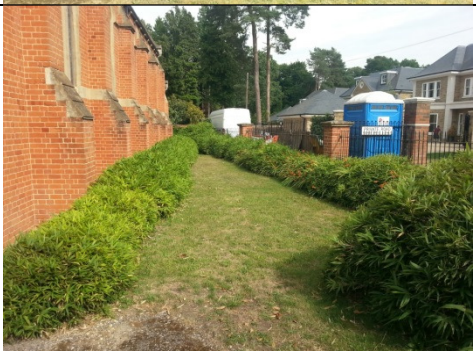
6.4.2	The landed area along Friary Close. The planting alongside the Church is bamboo which needs to be rigorously kept under control.	Regular cutting back of the bamboo, and clearance from the moat which protects the Church from damp ingress.	M

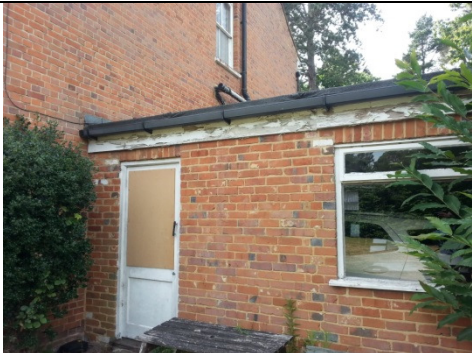
No.	Condition	Repair Need	Repair Type	Photograph
6.5.1	The exterior requires decorating, the timber doors and windows need to be replaced. The felt roof would benefit from a cap sheet and repairs to the flashings.	None if this is planned for removal. If it is to be retained long term, then a comprehensive overhaul is required.	E

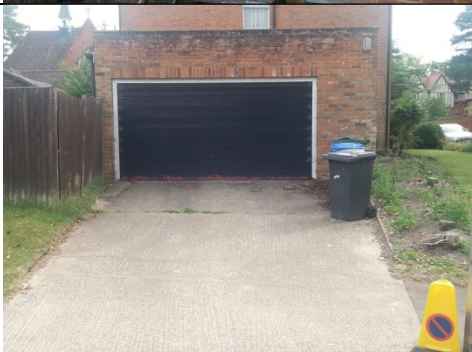
6.5.2	The front of the garage and showing the concrete drive.	As 6.5.1	E

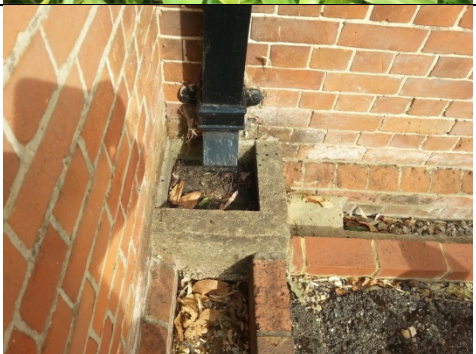
6.6.2	Missing grating on this slipper gully, which takes combined waste and surface water.	Provide grating.	C	 
6.6.3	As 6.6.1	As 6.6.1	M	 
6.6.4	As 6.6.1	As 6.6.1	M	 
6.6.5	As 6.6.1 This is within the moat along the side of the Church.	As 6.6.1	M	 
6.6.6	As 6.6.1 This is at the front corner of the Church and the gully must be kept clear to enable water from the downpipe to run away to the channels.	As 6.6.1	M

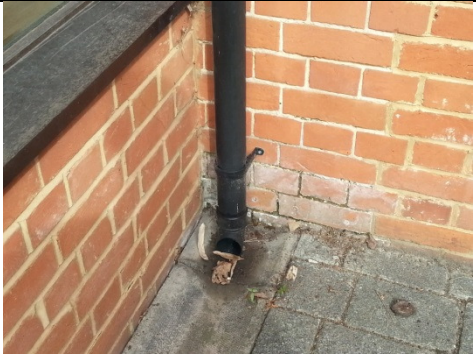
6.6.7	The downpipe adjacent the entrance porch discharges into a shallow dished gully and then down to a small channel drain. The water does not clear this area in heavy rain and is saturating the brickwork and most likely part of the cause of the internal damp in this location.	Cut out the paving and install a drain and discharge the rainwater direct into it. Alternatively cut out along the face of the walls and construct new channel drains.	C

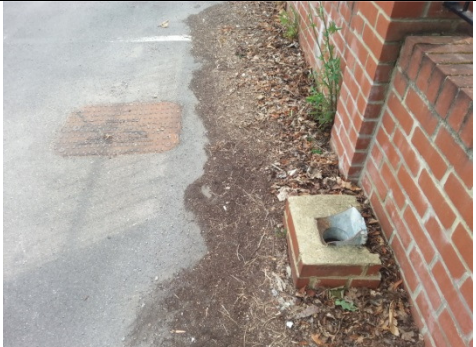
6.6.9	This is most likely a vent pipe from the main drain visible top left. It has been fractured.	Check whose responsibility this is. Repair if required.	E
